REPORT
On field tests
For rubble victims detection PicoR-Bio
At Russian Emergency Situation Ministry test range
(Noginsk City, Moscow region) 11.10.2012

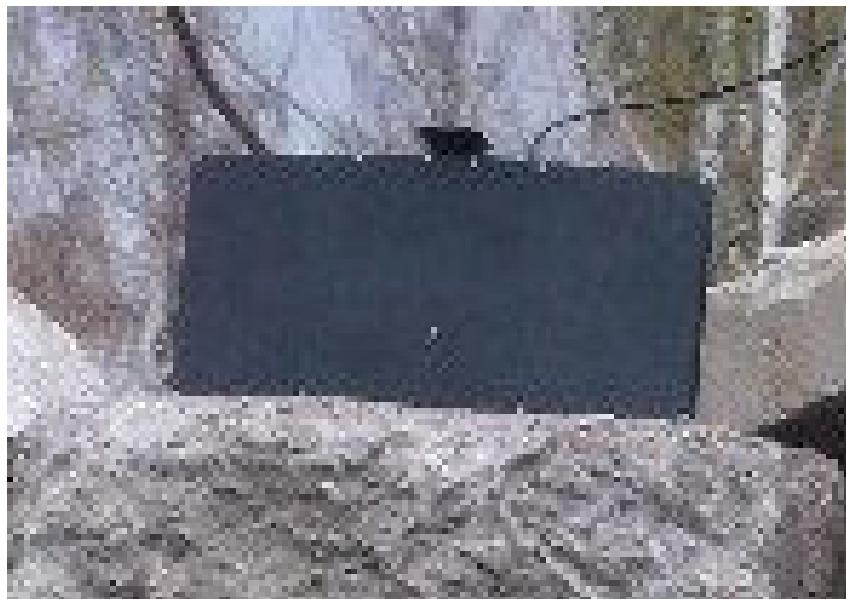
Pic. 1. PicoR AM1

- antenna module based on printed antennas (hereinafter - PicoR AM1 module) (pic. 1);
- antenna module based on horn antennas (hereinafter - PicoR AM2 module) (pic. 2);
- laptop with Ski-Bio software (pic. 3)

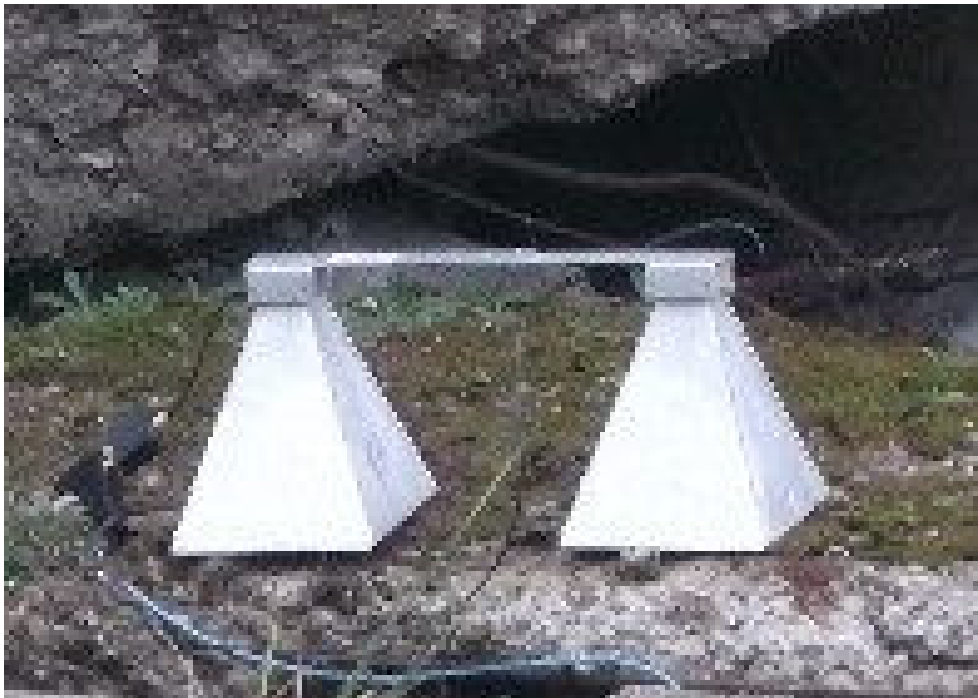
Pic. 2. Module PicoR AM2

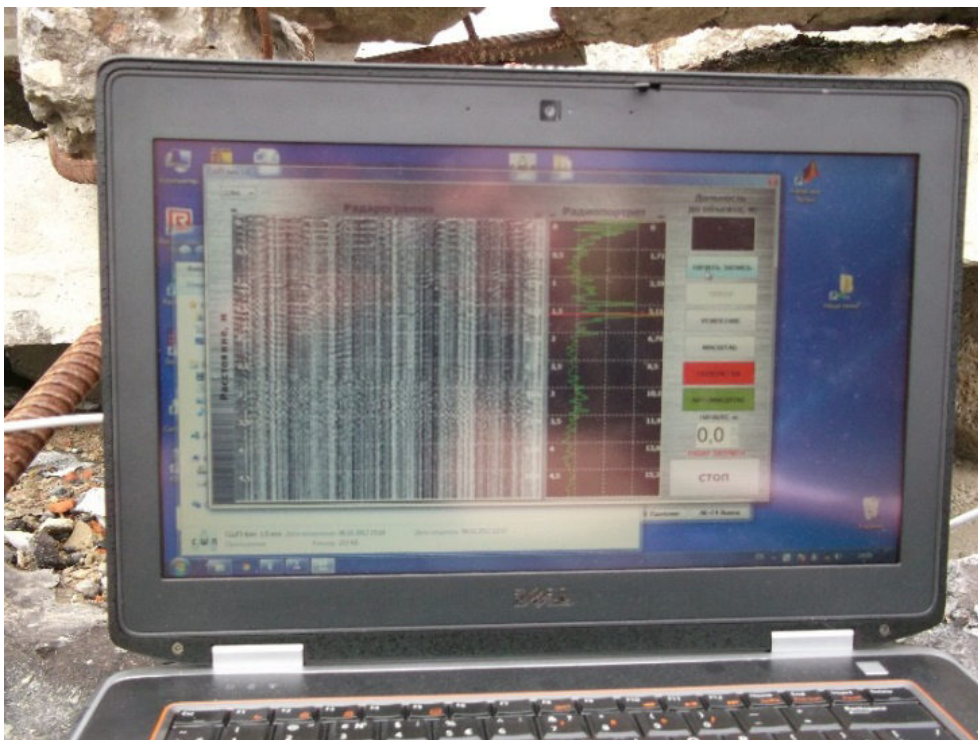
Pic. 3. Laptop with SKI-Bio software

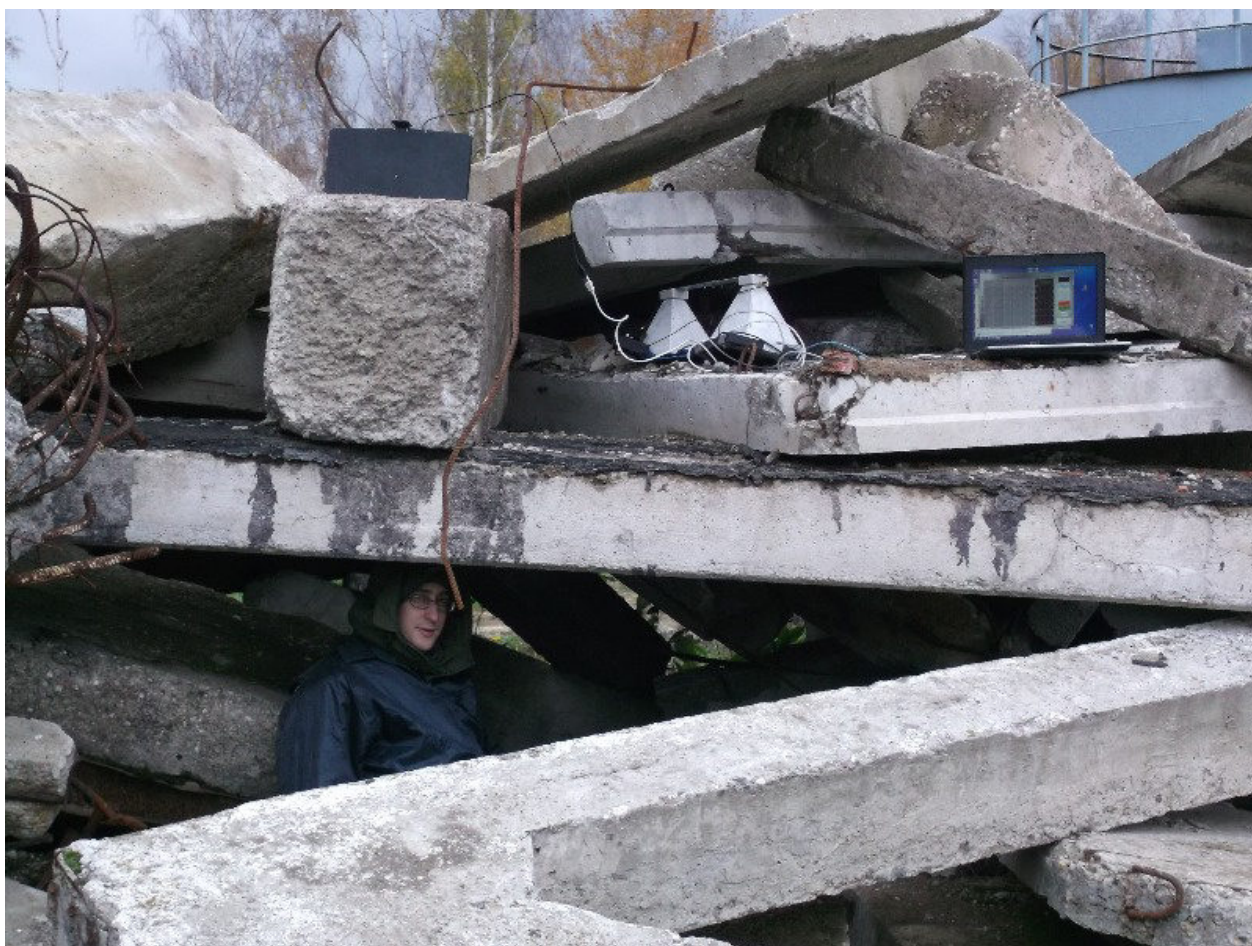
Pic. 4. Test site № 1
(Human detection through 2 concrete slabs)

- measurements through two concrete slabs (pic.4) and through concrete slab-air- concrete slab (pic.5) were made;
- human is in sitting position;
- human movements – breathing, slight arm movements, torso turning;
- distance to antenna modules – 1,5-3 m;
- weather conditions: air T +5°C; no rain.

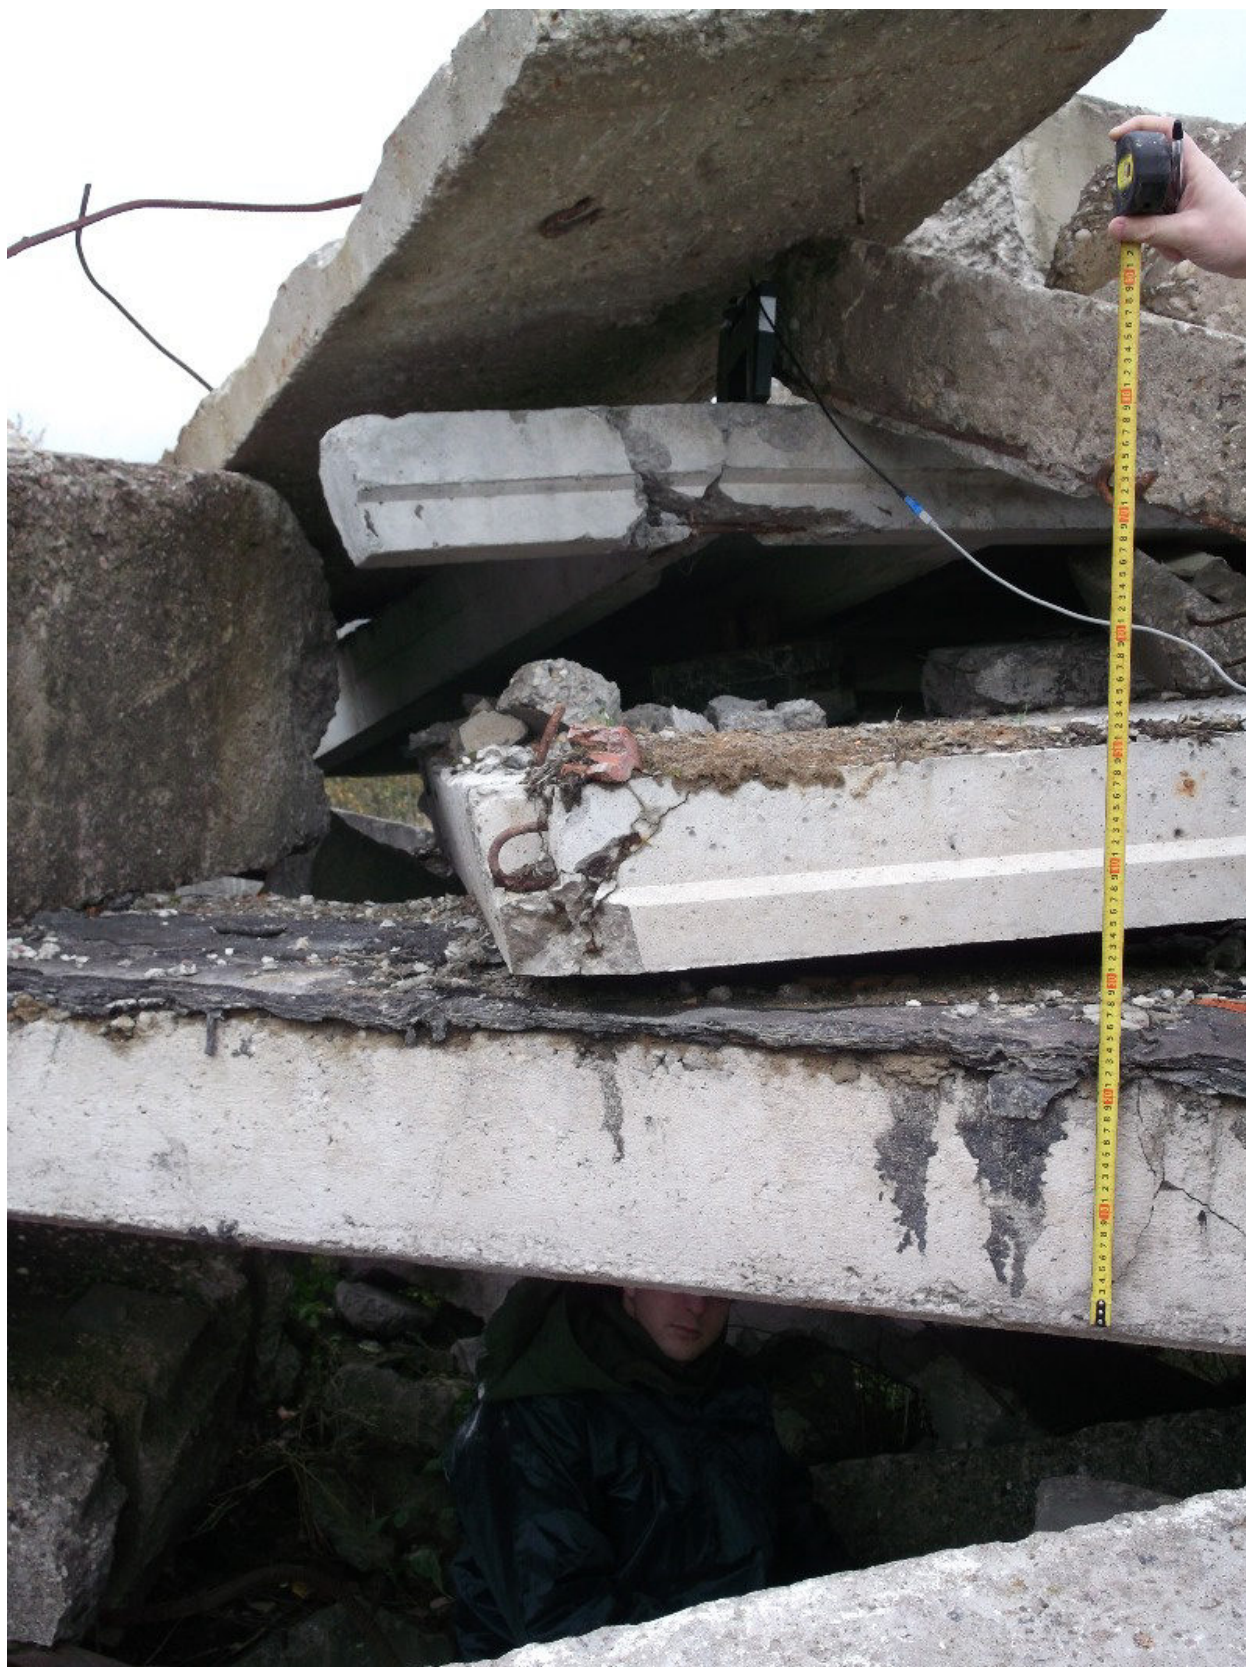
Рис. 5. Test site № 1
(human detection through concrete slab-air-concrete slab)

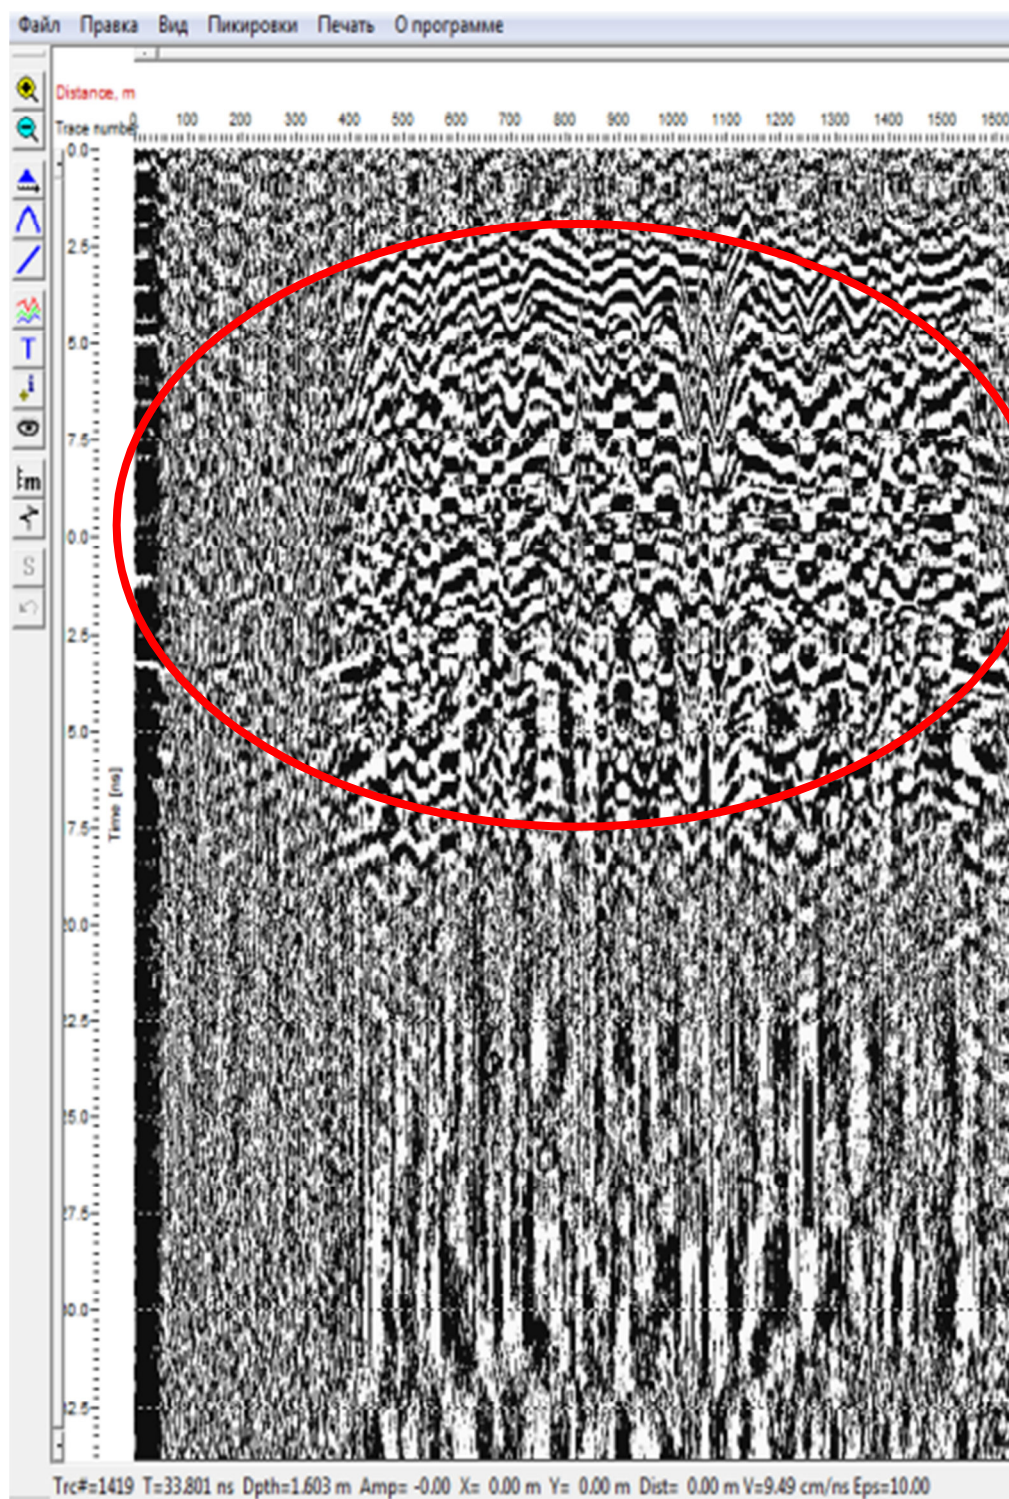
Fourth signal measurement was made through two concrete slabs with a human inside rubble via Picor AM2 module. Human was found (reflected signal is marked red).

Pic. 9. Radargram signal through two concrete slabs with a human inside rubble using PicoR AM2 (fourth signal measurement, test site № 1)

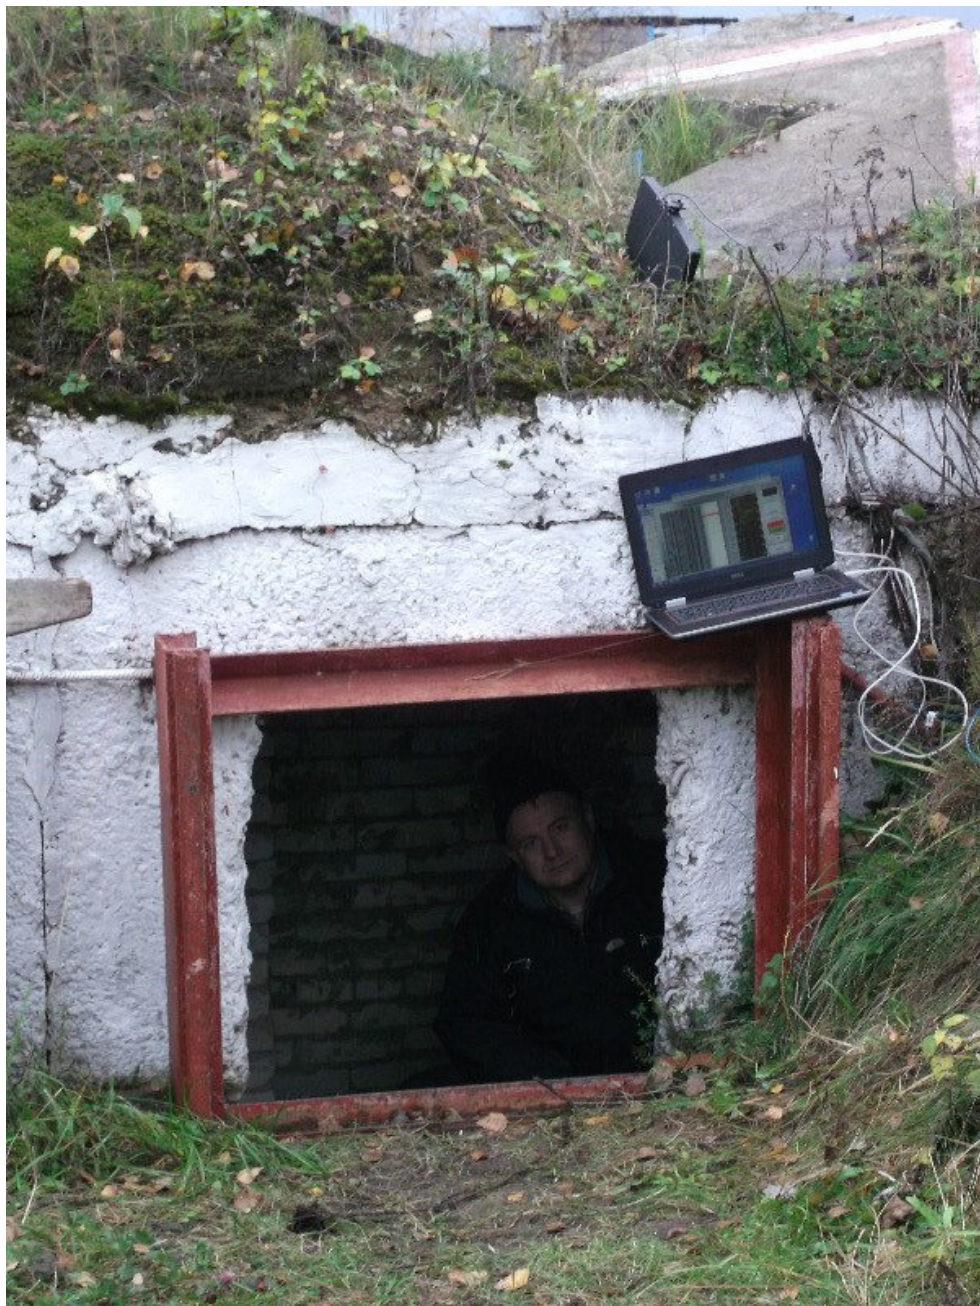
Pic. 12. Test site № 2

- signal measurement through soil and concrete slab was made (pic. 12);
- human is in sitting position;
- human movements – breathing, arm slight moving, torso turning;
- distance to antenna modules – 1,5-2 m;
- weather conditions: air $T = +5^{\circ}\text{C}$; drizzle .

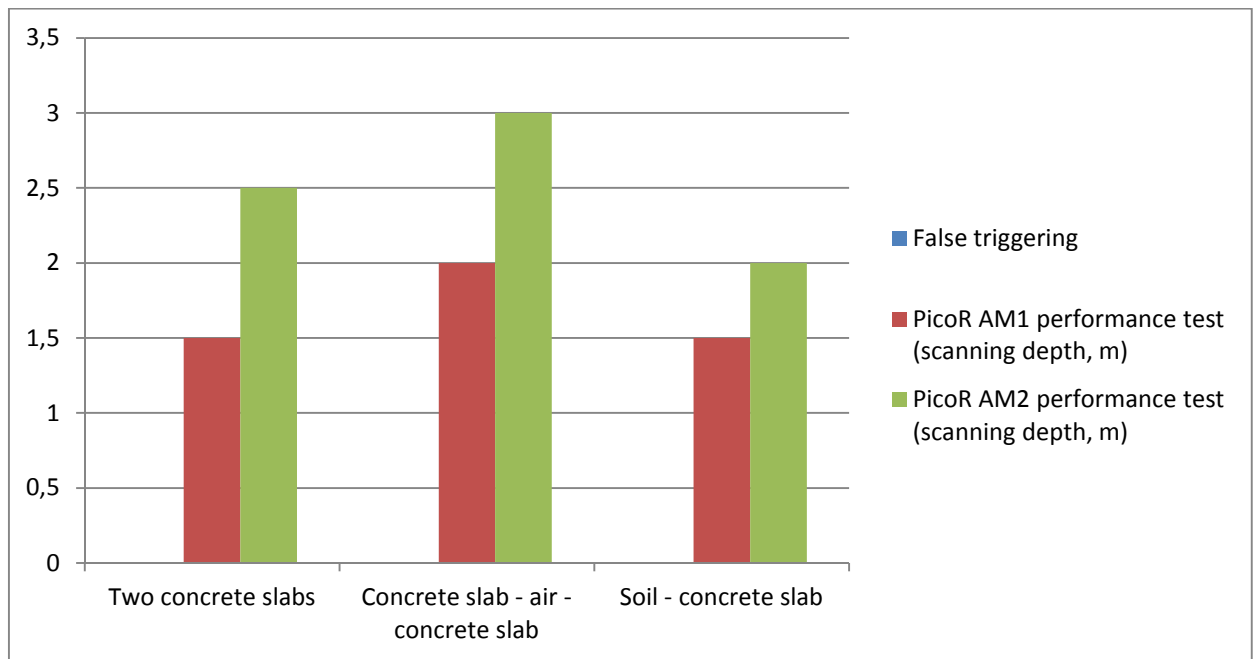
The chart below displays test results on two test sites (pic 17).

Pic. 17. Test results for two test sites

- under two concrete slabs at 1,5m depth using PicoR AM 1;
- under two concrete slabs at 2,5m depth using PicoR AM 2;
- under concrete slab-air-concrete slab at 2m depth using PicoR AM1;
- under concrete slab-air-concrete slab at 3m depth using PicoR AM2;

- under soil-concrete slab at 1,5m depth using PicoR AM1;
- under soil-concrete slab at 2m depth using PicoR AM2.

Thereby, human identification depth using PicoR AM2 is 1,5-2 times higher, than PicoR AM1.
